# Manhole Inspection Summary

Manhole # S190\_\_003MH

Insp Date: **3/14/08 12:36 PM**

**Location** Address: **601 s pulaski st**

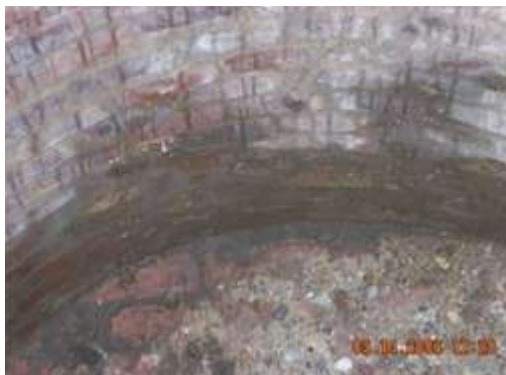
Defect 4

Infiltration: ☐ None ☐ Joint ☐ Cracks ☐ Mortar ☐ Roots ☒ **Wall**

infiltration @ barrel wall

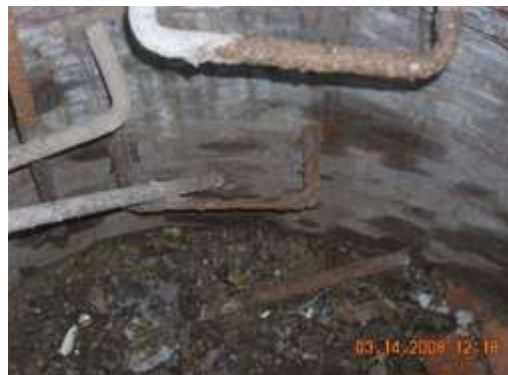
Defect 3

**Steps** Count: **4** Missing: **0** ☒ **Corroded**

corroded steps

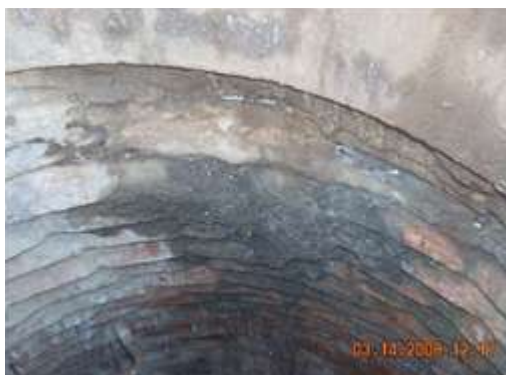
Defect 2

Infiltration: ☐ None ☒ **Joint** ☐ Cracks ☐ Mortar ☐ Roots ☐ Wall

infiltration evidence @ chimney joint

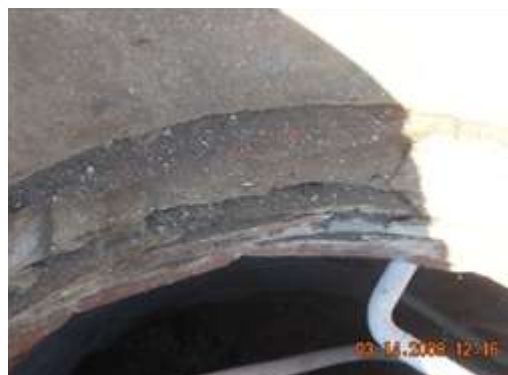
Defect 1

**Frame** Offset: **1** (in.) Condition: ☒ Sound ☐ Cracked ☐ Leaks

frame offset

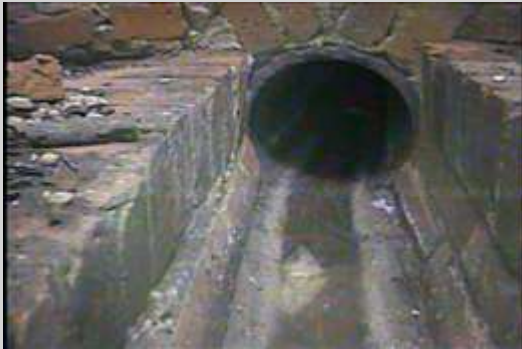
12 O'Clock Outflow

8 in. Circular Gravity Sewer  
Pipe Out @ 12 O'Clock

Pipe Height: **8.4** (in.) Rod and Bar (Angled)  
Pipe Material: **Clay** ☐ Pipe Lined  
Invert Depth: **7.49** (ft.) Flow Characteristics: **Slow**  
Deposits: ☒ None ☐ Mud ☐ Sludge ☐ Debris ☐ Grease  
Silt Depth: **0** (in.) Deposits Extent:  
Infiltration: **None** Pipe Seal Cond: **Sound**

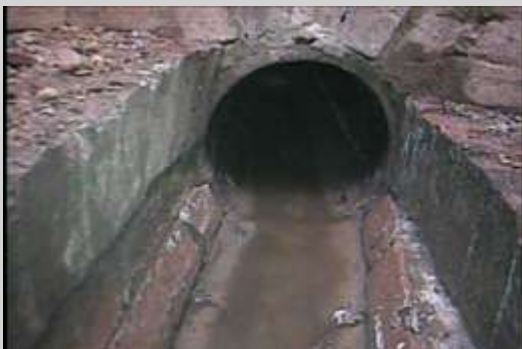
6 O'Clock Inflow

8 in. Circular Gravity Sewer  
Pipe In @ 6 O'Clock

Pipe Height: **8.4** (in.) Rod and Bar (Angled)  
Pipe Material: **Clay** ☐ Pipe Lined  
Invert Depth: **7.37** (ft.) Flow Characteristics: **Slow**  
Deposits: ☒ None ☐ Mud ☐ Sludge ☐ Debris ☐ Grease  
Silt Depth: **0** (in.) Deposits Extent:  
Infiltration: **None** Pipe Seal Cond: **Sound**
